GEOTECHNICAL DATA AS SHOWN
 PER REPORT PREPARED BY
 GIBLIN ASSOCIATES DATED
 OCTOBER 13, 2005

**OAT HILL PROPERTIES
 GEOTECHNICAL CONSTRAINTS MAP
 NAPA COUNTY
 CALIFORNIA**

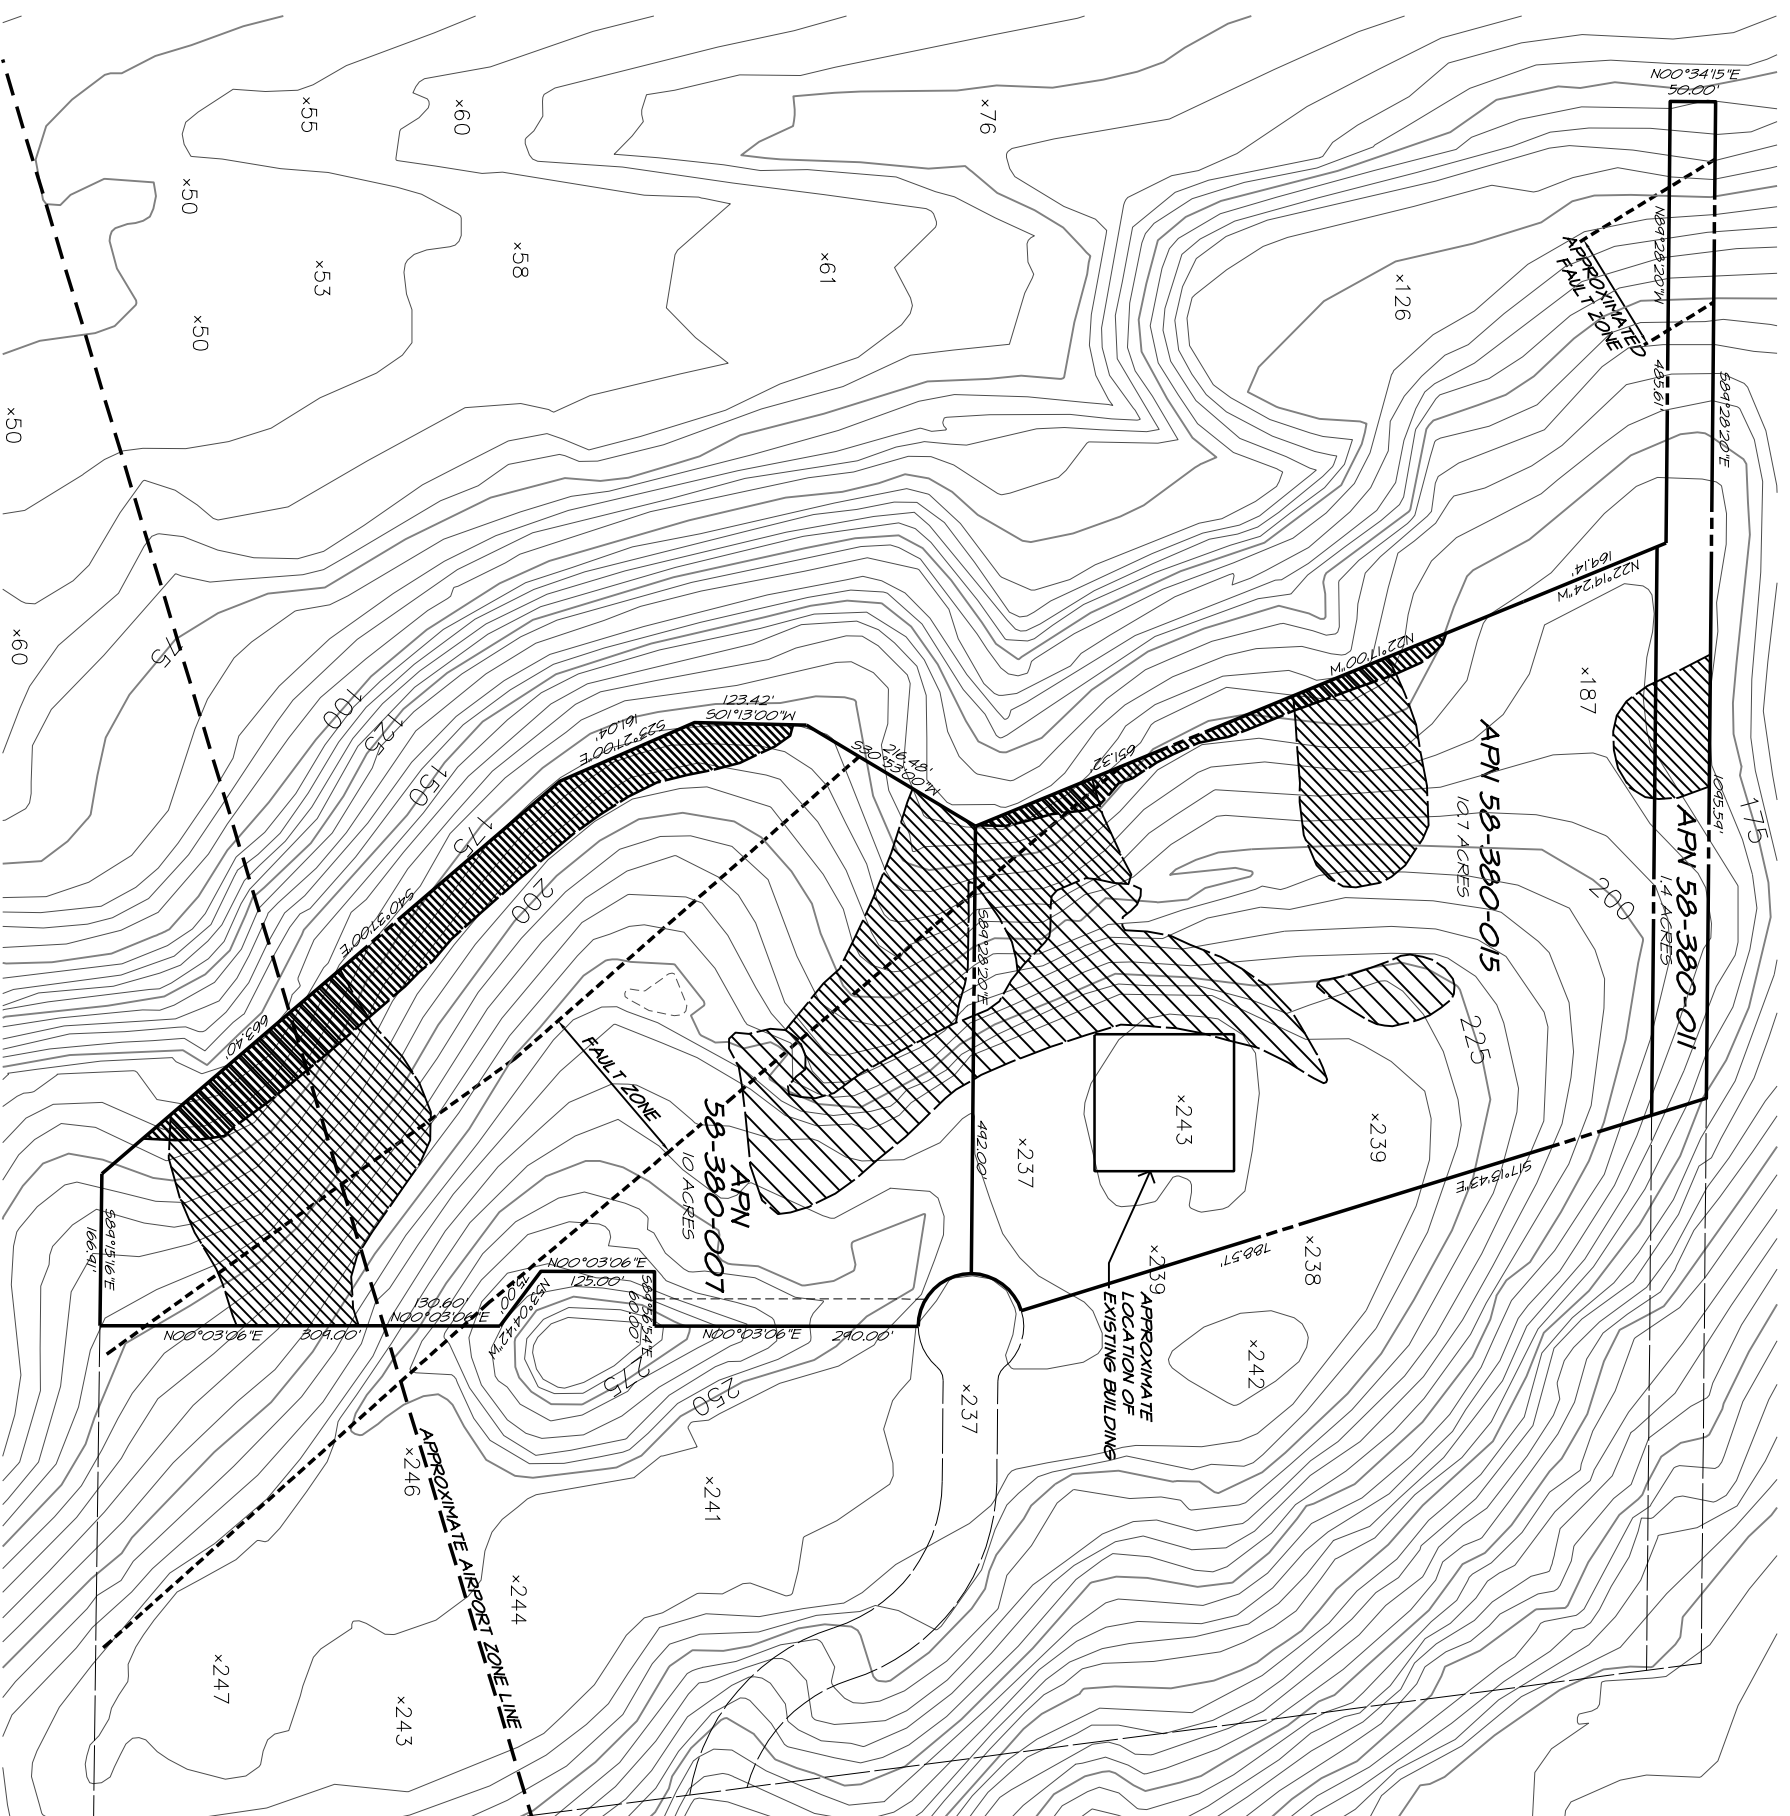
GEOTECHNICAL DATA

AREAS OF FILL
-

AREAS OF SLOPE INSTABILITY
-

QUARRY SLOPE SETBACK
-

FAULT T ZONE BOUNDARY
